**Flood Control Project Maintenance  
Levee Inspections**

**Maintenance Issue Types Only, Levee Inspection Report By Mile - Fall 2016**

**Tehama County Flood Control and Water Conservation District**

Waterway	Bank	Unit Miles	Inspection Start/End	Inspector
Unit No. 01 Deer Creek	Left	4.22	10/24/2016 10/24/2016	Tariq Chechi

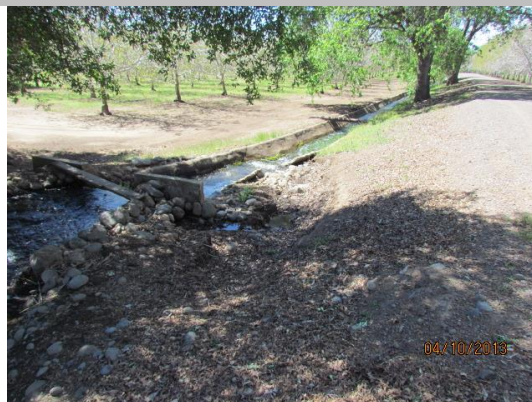
Photo 1 of 1 : FA\_2016\_NA0019\_78\_17\_20160823\_00004.jpg

LM Start	0.01	Rating **	M	Issue No.	17
LM End	0.01	Issue Type +	Ma	Location *	LS
Category	Earthen Levee			GPS Latitude/Longitude	
				Start	End
Item	Erosion / Bank Caving			39.973111 °	39.973111 °
				-121.980466 °	-121.980466 °
DWR ID	DWR_NA0019_01_s_2013_17				
Comment Code					
E1 : Note and monitor erosion site.					
Inspector Comment

View of the erosion along the landside slope.

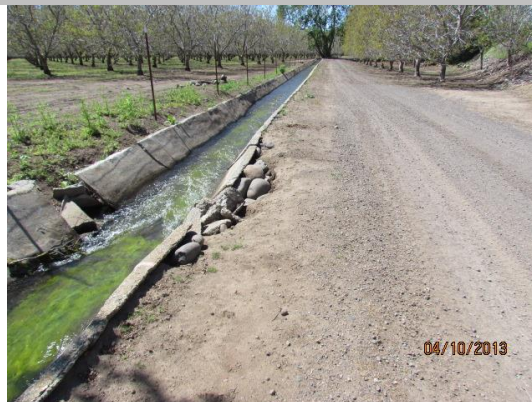
Photo 1 of 1 : FA\_2016\_NA0019\_78\_18\_20160823\_00005.jpg

LM Start	0.41	Rating **	M	Issue No.	18
LM End	0.41	Issue Type +	Ma	Location *	LS
Category	Earthen Levee			GPS Latitude/Longitude	
				Start	End
Item	Erosion / Bank Caving			39.972560 °	39.972560 °
				-121.987759 °	-121.987759 °
DWR ID	DWR_NA0019_01_s_2013_18				
Comment Code					
E1 : Note and monitor erosion site.					
Inspector Comment

View of the erosion along the landside slope.

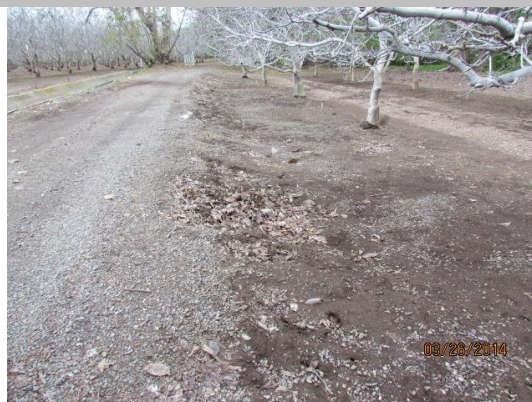
Photo 1 of 1 : FA\_2016\_NA0019\_78\_276\_20160823\_00014.jpg

LM Start	0.45	Rating **	M	Issue No.	276
LM End	0.45	Issue Type +	Ma	Location *	WS
Category	Earthen Levee			GPS Latitude/Longitude	
				Start	End
Item	Slope Stability			39.972377 °	39.972377 °
				-121.988559 °	-121.988559 °
DWR ID	DWR_NA0019_01_s_2014_276				
Comment Code					
S1 : Repair slope instability.					
Inspector Comment

View of the erosion along the waterside slope.

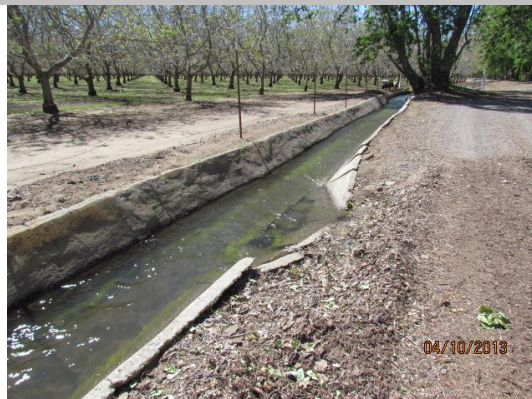
Photo 1 of 1 : FA\_2016\_NA0019\_78\_19\_20160823\_00006.jpg

LM Start	0.46	Rating **	M	Issue No.	19
LM End	0.46	Issue Type +	Ma	Location *	LS
Category	Earthen Levee			GPS Latitude/Longitude	
				Start	End
Item	Erosion / Bank Caving			39.972339 °	39.972339 °
				-121.988763 °	-121.988763 °
DWR ID	DWR_NA0019_01_s_2013_19				
Comment Code					
E1 : Note and monitor erosion site.					
Inspector Comment

View of the erosion along the landside slope.

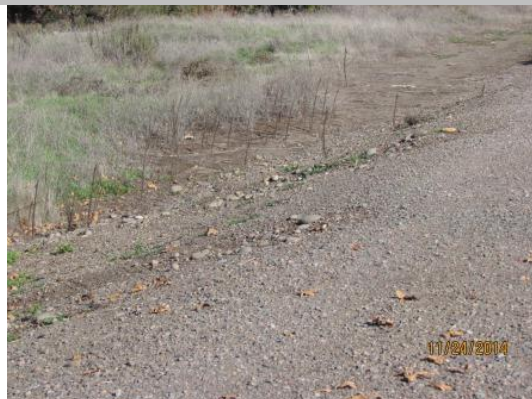
Photo 1 of 1 : FA\_2016\_NA0019\_78\_38\_20160823\_00010.jpg

LM Start	2.86	Rating **	M	Issue No.	38
LM End	2.86	Issue Type +	Ma	Location *	LS
Category	Earthen Levee			GPS Latitude/Longitude	
				Start	End
Item	Slope Stability			39.963928 °	39.963928 °
				-122.030120 °	-122.030120 °
DWR ID	DWR_NA0019_01_f_2014_38				
Comment Code					
S1 : Repair slope instability.					
Inspector Comment

View of erosion from the cattle on both slopes.

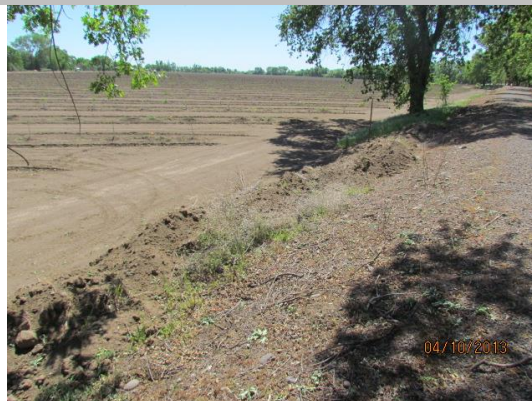
Photo 1 of 1 : FA\_2016\_NA0019\_78\_20\_20160823\_00007.jpg

LM Start	2.88	Rating **	M	Issue No.	20
LM End	2.88	Issue Type +	Ma	Location *	LS
Category	Earthen Levee			GPS Latitude/Longitude	
				Start	End
Item	Slope Stability			39.963709 °	39.963709 °
				-122.030384 °	-122.030384 °
DWR ID	DWR_NA0019_01_s _ 2013_20				
Comment Code					
S1 : Repair slope instability.					
Inspector Comment

View of the erosion along the landside slope.

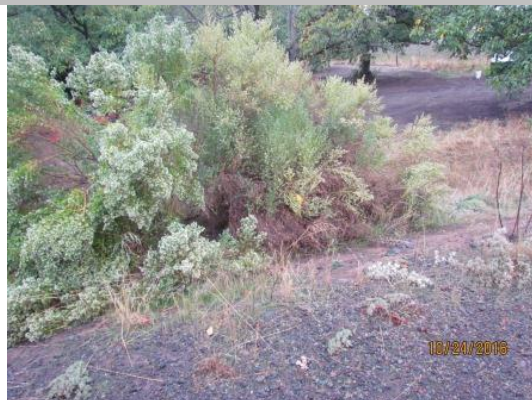
Photo 1 of 1 : FA\_2016\_NA0019\_78\_16\_20161107\_00058.jpg

LM Start	3.75	Rating **	M	Issue No.	16
LM End	3.75	Issue Type +	Ma	Location *	LS
Category	Earthen Levee			GPS Latitude/Longitude	
				Start	End
Item	Vegetation			39.944407 °	39.944407 °
				-122.054104 °	-122.054104 °
DWR ID	DWR_NA0019_01_f_2016_16				
Comment Code					
V2 : Remove the wild growth other than native grasses from the levee slopes.					
Inspector Comment

View of a bush obstructing visibility.

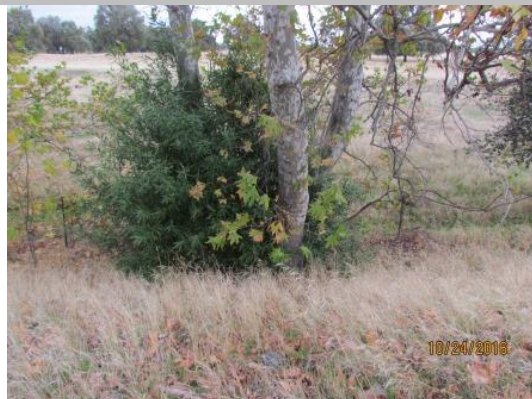
Photo 1 of 1 : FA\_2016\_NA0019\_79\_13\_20161107\_00013.jpg

LM Start	0.23	Rating **	M	Issue No.	13
LM End	0.23	Issue Type +	Ma	Location *	LS
Category	Earthen Levee			GPS Latitude/Longitude	
				Start	End
Item	Trim / Thin Trees			39.970598°	39.970598°
				-122.013053°	-122.013053°
DWR ID	DWR_NA0019_02_f_2016_13				
Comment Code					
T1 : Trim trees to at least five feet above ground level.					
Inspector Comment

View of a tree with new thick growth blocking visibility.

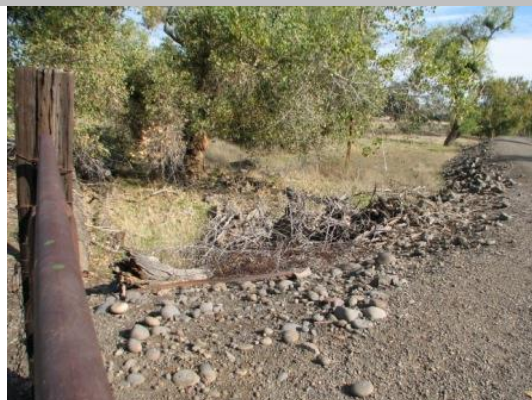
Photo 1 of 1 : FA\_2016\_NA0019\_79\_2\_20160823\_00001.jpg

LM Start	0.30	Rating **	M	Issue No.	2
LM End	0.30	Issue Type +	Ma	Location *	LS
Category	Earthen Levee			GPS Latitude/Longitude	
				Start	End
Item	Encroachments			39.970305 °	39.970305 °
				-122.014465 °	-122.014465 °
DWR ID	DWR_NA0019_02_s_2012_2				
Comment Code					
DE : Debris					
Inspector Comment

View of debris and wire at the toe of levee.

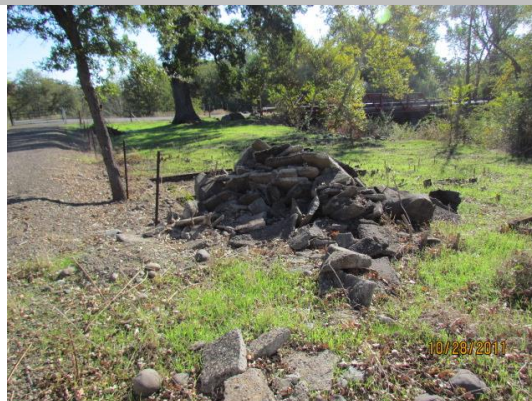
Photo 1 of 1 : FA\_2016\_NA0019\_79\_4\_20160823\_00003.jpg

LM Start	0.34	Rating **	M	Issue No.	4
LM End	0.34	Issue Type +	Ma	Location *	WS
Category	Earthen Levee			GPS Latitude/Longitude	
				Start	End
Item	Encroachments			39.970210°	39.970210°
				-122.015198°	-122.015198°
DWR ID	DWR_NA0019_02_s_2012_4				
Comment Code					
DE : Debris					
Inspector Comment

View of the concrete pile along the waterside toe.

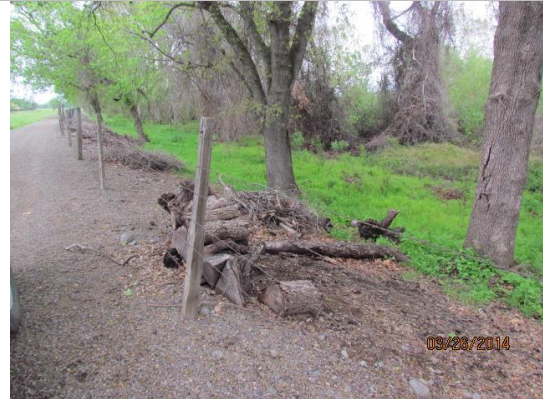
Photo 1 of 1 : FA\_2016\_NA0019\_79\_6\_20160823\_00004.jpg

LM Start	1.28	Rating **	M	Issue No.	6
LM End	1.28	Issue Type +	Ma	Location *	WS
Category	Earthen Levee			GPS Latitude/Longitude	
				Start	End
Item	Encroachments			39.964883 °	39.964883 °
				-122.030655 °	-122.030655 °
DWR ID	DWR_NA0019_02_s_2012_6				
Comment Code					
FW : Firewood					
Inspector Comment

View of the firewood along the waterside slope.

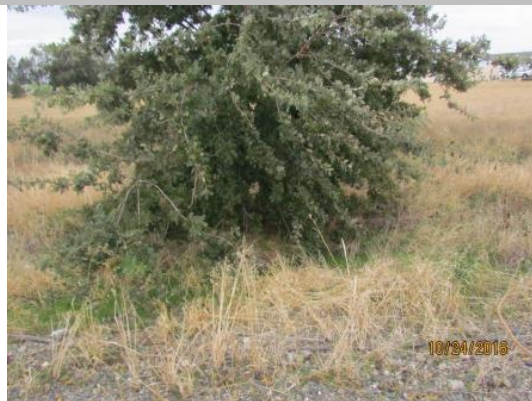
Photo 1 of 1 : FA\_2016\_NA0019\_81\_13\_20161107\_00026.jpg

LM Start	0.73	Rating **	M	Issue No.	13
LM End	0.73	Issue Type +	Ma	Location *	LS
Category	Earthen Levee			GPS Latitude/Longitude	
				Start	End
Item	Trim / Thin Trees			40.052003°	40.052003°
				-122.175687°	-122.175687°
DWR ID	DWR_NA0019_04_f_2016_13				
Comment Code					
T1 : Trim trees to at least five feet above ground level.					
Inspector Comment

View of a tree with overhanging branches.

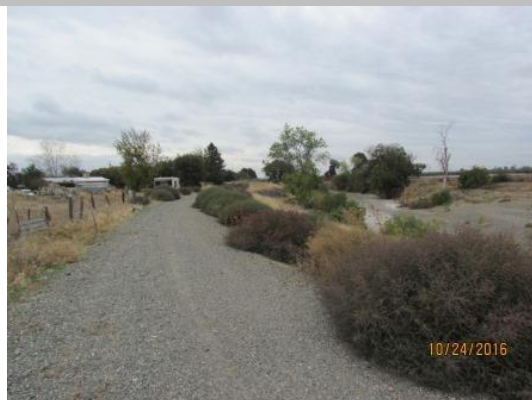
Photo 1 of 1 : FA\_2016\_NA0019\_81\_26\_20161107\_00027.jpg

LM Start	0.96	Rating **	M	Issue No.	26
LM End	1.07	Issue Type +	Ma	Location *	WS
Category	Earthen Levee			GPS Latitude/Longitude	
				Start	End
Item	Vegetation			40.053431 °	40.052410 °
				-122.171961 °	-122.170275 °
DWR ID	DWR_NA0019_04_f_2016_26				
Comment Code					
V1 : Control annual grass and weeds on the levee slopes and easements.					
Inspector Comment

View of the annual vegetation along the waterside crown and slope.

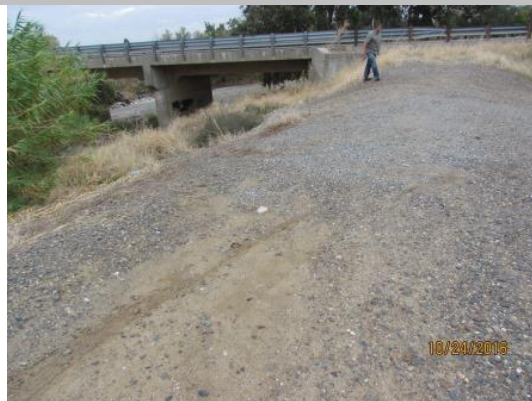
Photo 1 of 1 : FA\_2016\_NA0019\_81\_27\_20161107\_00028.jpg

LM Start	1.12	Rating **	M	Issue No.	27
LM End	1.12	Issue Type +	Ma	Location *	CR
Category	Earthen Levee			GPS Latitude/Longitude	
				Start	End
Item	Slope Stability			40.051950°	40.051950°
				-122.169872°	-122.169872°
DWR ID	DWR_NA0019_04_f_2016_27				
Comment Code					
S3 : Repair the levee slope damaged by vehicle traffic and prevent access where possible.					
Inspector Comment

View of the slope instability caused by vehicles.

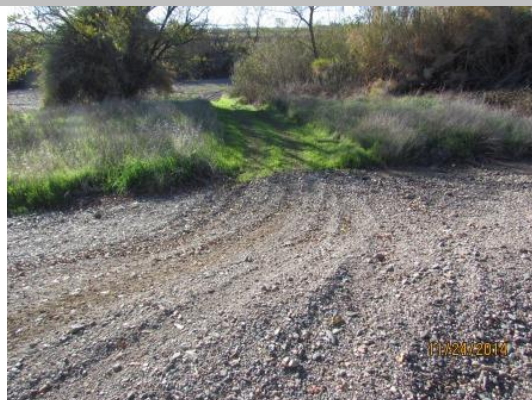
Photo 1 of 1 : FA\_2016\_NA0019\_81\_16\_20160823\_00010.jpg

LM Start	1.39	Rating **	M	Issue No.	16	
LM End	1.39	Issue Type +	Ma	Location *	WS	
Category	Earthen Levee			GPS Latitude/Longitude		
				Start		End
Item	Slope Stability			40.051493 °		40.051493 °
				-122.164935 °		-122.164935 °
DWR ID	DWR_NA0019_04_f_2014_16					
Comment Code						
S3 : Repair the levee slope damaged by vehicle traffic and prevent access where possible.						
Inspector Comment

View of the slope instability caused by vehicles along the waterside slope.

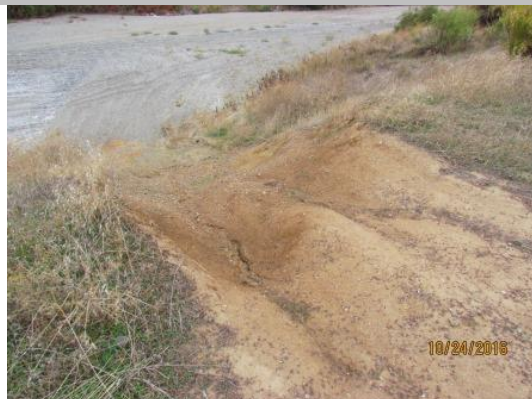
Photo 1 of 1 : FA\_2016\_NA0019\_81\_29\_20161107\_00029.jpg

LM Start	1.44	Rating **	M	Issue No.	29
LM End	1.44	Issue Type +	Ma	Location *	WS
Category	Earthen Levee			GPS Latitude/Longitude	
				Start	End
Item	Slope Stability			40.051785 °	40.051785 °
				-122.164075 °	-122.164075 °
DWR ID	DWR_NA0019_04_f_2016_29				
Comment Code					
S3 : Repair the levee slope damaged by vehicle traffic and prevent access where possible.					
Inspector Comment

View of the slope instability caused by vehicles along the waterside slope.

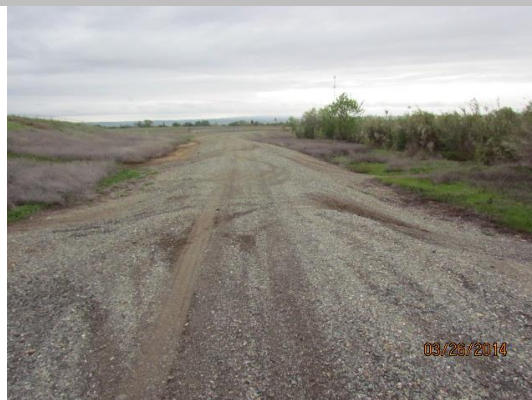
Photo 1 of 2 : FA\_2016\_NA0019\_81\_3\_20160823\_00003.jpg

LM Start	1.59	Rating **	M	Issue No.	3
LM End	1.59	Issue Type +	Ma	Location *	WS
Category	Earthen Levee			GPS Latitude/Longitude	
				Start	End
Item	Slope Stability			40.052607°	40.052705°
				-122.161418°	-122.161442°
DWR ID	DWR__04_s_2012_3				
Comment Code					
S3 : Repair the levee slope damaged by vehicle traffic and prevent access where possible.					
Inspector Comment					
Tehama Co. repaired the slope that was damaged by vehicle traffic, but the damage has returned. On 4/26/16, vehicle erosion area was repaired again, but should be monitored.

View of the levee slope damaged by vehicle traffic.

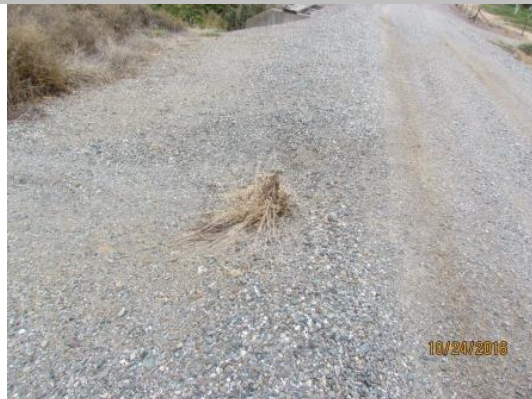
Photo 2 of 2 : FA\_2016\_NA0019\_81\_3\_20161107\_00030.jpg

LM Start	<b>1.59</b>	Rating **	M	Issue No.	<b>3 (cont)</b>
LM End	<b>1.59</b>	Issue Type +	Ma	Location *	WS

View of a dip along the levee slope.

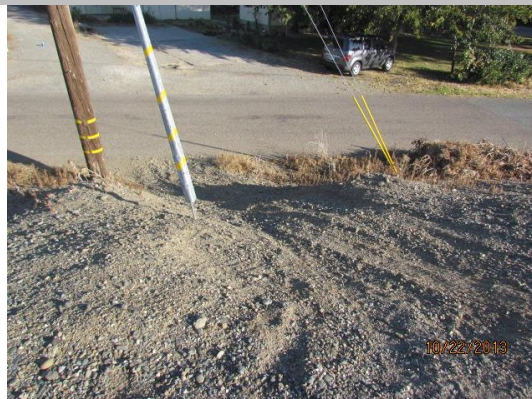
Photo 1 of 1 : FA\_2016\_NA0019\_81\_12\_20160823\_00006.jpg

LM Start	2.32	Rating **	M	Issue No.	12
LM End	2.32	Issue Type +	Ma	Location *	LS
Category	Earthen Levee			GPS Latitude/Longitude	
				Start	End
Item	Slope Stability			40.052443 °	40.052443 °
				-122.148863 °	-122.148863 °
DWR ID	DWR_NA0019_04_f_2013_12				
Comment Code					
S3 : Repair the levee slope damaged by vehicle traffic and prevent access where possible.					
Inspector Comment

View of the slope instability caused by vehicles along the landside slope.

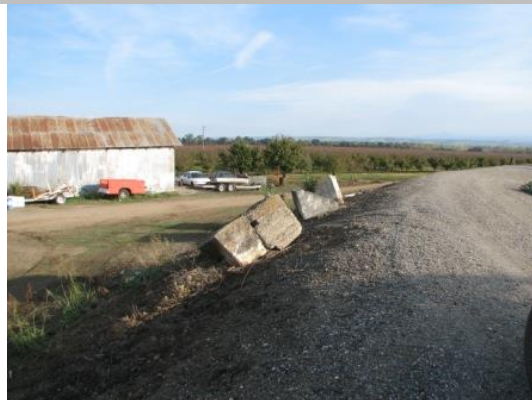
Photo 1 of 1 : FA\_2016\_NA0019\_81\_1\_20160823\_00001.jpg

View of the concrete stairways on the slope.

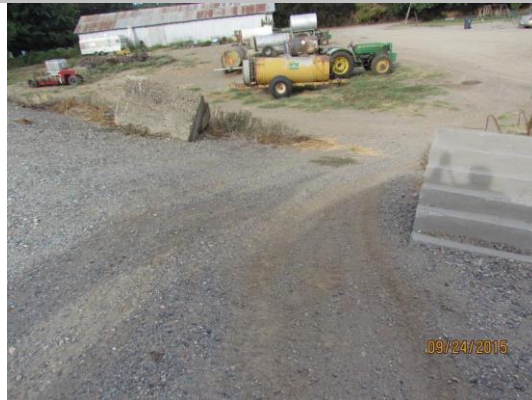
Photo 1 of 1 : FA\_2016\_NA0019\_81\_25\_20160823\_00019.jpg

LM Start	3.13	Rating **	M	Issue No.	25
LM End	3.13	Issue Type +	Ma	Location *	LS
Category	Earthen Levee			GPS Latitude/Longitude	
				Start	End
Item	Slope Stability			40.057350 °	40.057350 °
				-122.137667 °	-122.137667 °
DWR ID	DWR_NA0019_04_f_2015_25				
Comment Code					
S3 : Repair the levee slope damaged by vehicle traffic and prevent access where possible.					
Inspector Comment

View of the slope instability caused by vehicles along the landside slope.

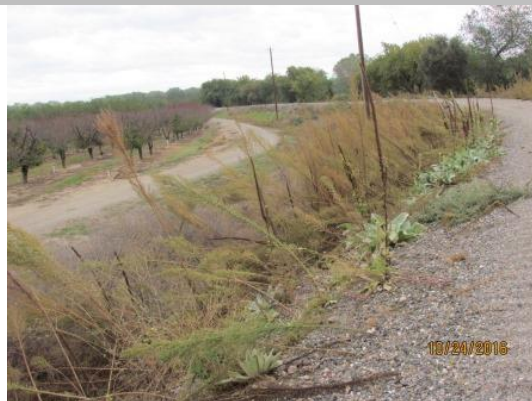
Photo 1 of 1 : FA\_2016\_NA0019\_81\_40\_20161107\_00038.jpg

View of the annual grass along the landside slope.

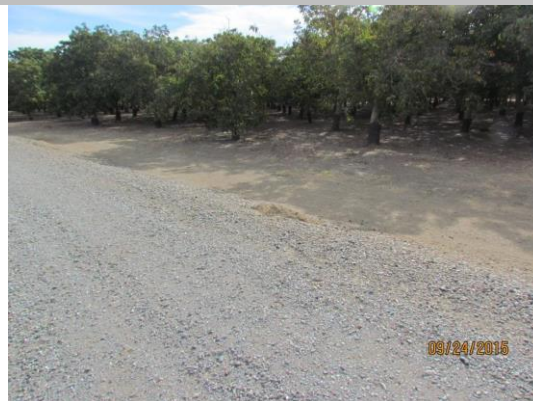
Photo 1 of 1 : FA\_2016\_NA0019\_82\_8\_20160823\_00003.jpg

View of the rodent holes along the landside slope.

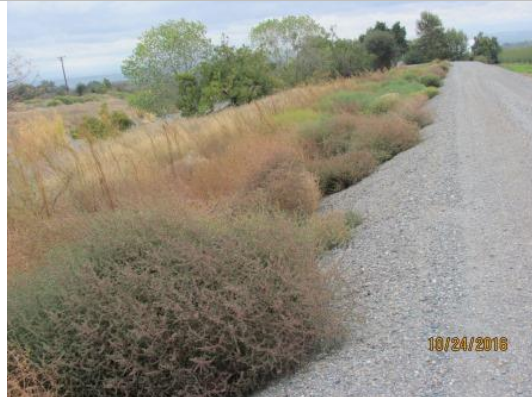
Photo 1 of 1 : FA\_2016\_NA0019\_82\_15\_20161107\_00017.jpg

View of the annual grass along the waterside slope.

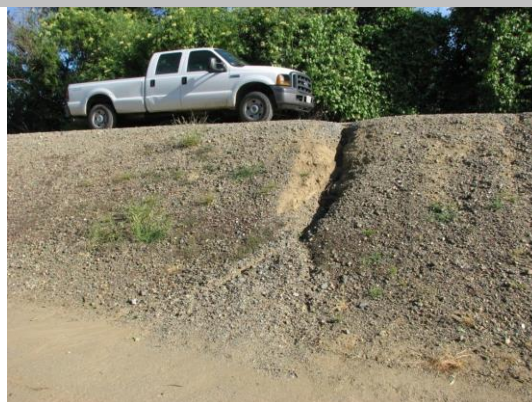
Photo 1 of 1 : FA\_2016\_NA0019\_82\_10\_20160823\_00004.jpg

LM Start	3.35	Rating **	U	Issue No.	10
LM End	3.35	Issue Type +	Ma	Location *	LS
Category	Earthen Levee			GPS Latitude/Longitude	
				Start	End
Item	Erosion / Bank Caving			40.056875 °	40.056875 °
				-122.135349 °	-122.135349 °
DWR ID	DWR_NA0019_05_s_2016_10				
Comment Code					
E2 : Schedule repair of erosion site prior to the next inspection.					
Inspector Comment					
Erosion rut running down LS slope from crown to toe

View of the erosion along the landside slope.

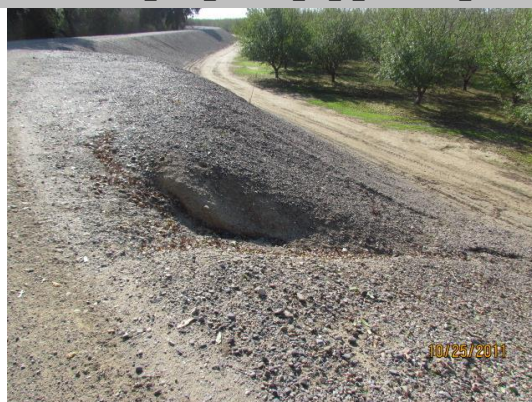
Photo 1 of 1 : FA\_2016\_NA0019\_82\_7\_20160823\_00002.jpg

LM Start	3.38	Rating **	U	Issue No.	7
LM End	3.38	Issue Type +	Ma	Location *	LS
Category	Earthen Levee			GPS Latitude/Longitude	
				Start	End
Item	Erosion / Bank Caving			40.056727 °	40.056727 °
				-122.134888 °	-122.134888 °
DWR ID	DWR_NA0019_05_s_2016_7				
Comment Code					
E2 : Schedule repair of erosion site prior to the next inspection.					
Inspector Comment

View of the erosion along the landside slope.

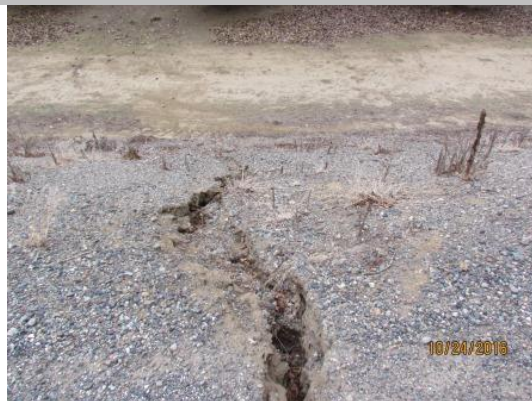
Photo 1 of 1 : FA\_2016\_NA0019\_82\_19\_20161107\_00018.jpg

LM Start	3.69	Rating **	M	Issue No.	19
LM End	3.69	Issue Type +	Ma	Location *	LS
Category	Earthen Levee			GPS Latitude/Longitude	
				Start	End
Item	Erosion / Bank Caving			40.054604 °	40.054604 °
				-122.130490 °	-122.130490 °
DWR ID	DWR_NA0019_05_f_2016_19				
Comment Code					
E2 : Schedule repair of erosion site prior to the next inspection.					
Inspector Comment

View of the erosion along the landside slope.

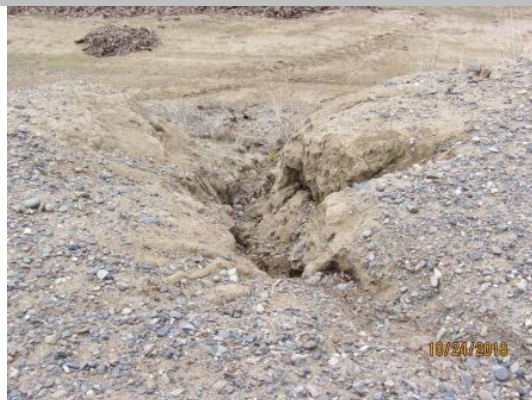
Photo 1 of 1 : FA\_2016\_NA0019\_82\_18\_20161107\_00019.jpg

LM Start	3.76	Rating **	U	Issue No.	18
LM End	3.76	Issue Type +	Ma	Location *	LS
Category	Earthen Levee			GPS Latitude/Longitude	
				Start	End
Item	Erosion / Bank Caving			40.054829 °	40.054829 °
				-122.129329 °	-122.129329 °
DWR ID	DWR_NA0019_05_f_2016_18				
Comment Code					
E2 : Schedule repair of erosion site prior to the next inspection.					
Inspector Comment

View of the erosion along the landside slope.
